Water Compliance Inspection Report

<p>Name and Location of Facility Inspected (For industrial users discharging to POTW, also include POTW name and NPDES permit number)</p> <p>Niagara Springs Hatchery - IDFG</p> <p>2131 Niagara Springs Road</p> <p>Hagerman, Idaho 83335 Wendell 83355 <i>JK</i></p> <p>Phone: (208) 536-2283 & Fax: Same (call first)</p>	<p>Entry Time/Date</p> <p>09:00 - Mar 09, 2015</p> <p>Exit Time/Date</p> <p>13:05 - Mar 09, 2015</p>	<p>Permit Effective Date</p> <p>December 1, 2007</p> <p>Permit Expiration Date</p> <p>November 30, 2012</p> <p>Administratively Extended</p>
<p>Name(s) of On-Site Representative(s)/Title(s)/Phone and Fax Numbers</p> <p>Mr. Jerry Chapman, Hatchery Manager II (IDFG) - Operator</p> <p>Mr. Brian Thompson, Assistant Manager (IDFG) - Assistant Operator</p> <p>Phone: (208) 536-2283 & Fax: Same (call first)</p>	<p>Other Facility Data (e.g., SIC, NAICS, and other descriptive information) 0921 <i>JK</i></p> <p>SIC = 0273 (Animal Aquaculture)</p> <p>NAICS = 112511 (Animal Aquaculture)</p>

Subject: Niagara Springs Hatchery, 2015 NPDES Inspection, NPDES Permit IDG-130013

Idaho Department of Environmental Quality AQUACULTURE FACILITY INSPECTION SUR

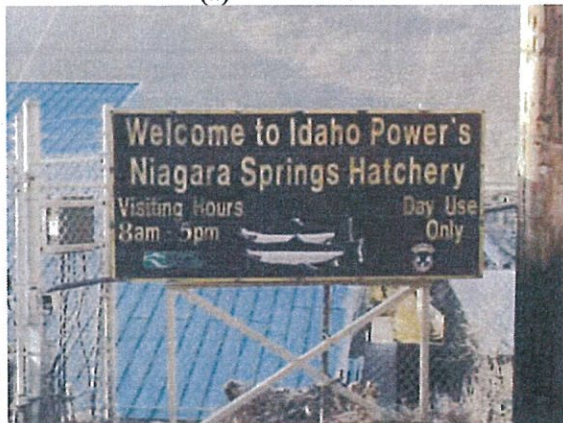
Digital 1. View from Niagara Springs Grade

(1) Front Entrance

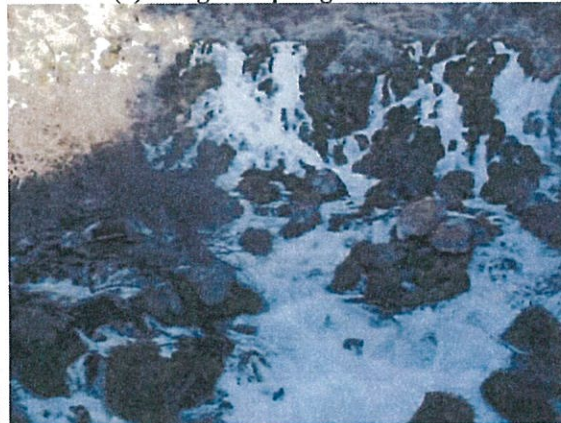
Digital 2. View from visitor's lookout area

(2) Niagara Springs Source Water

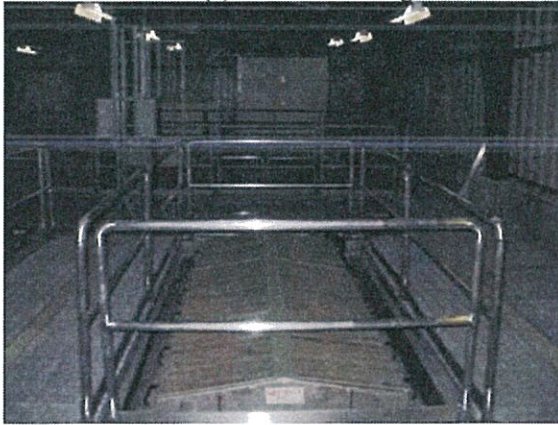
Digital 4. Northernmost in Filter Building

Mr. Chapman took IDEQ into their new Filter Building. The Filter Sump is lies below the filter compartments.

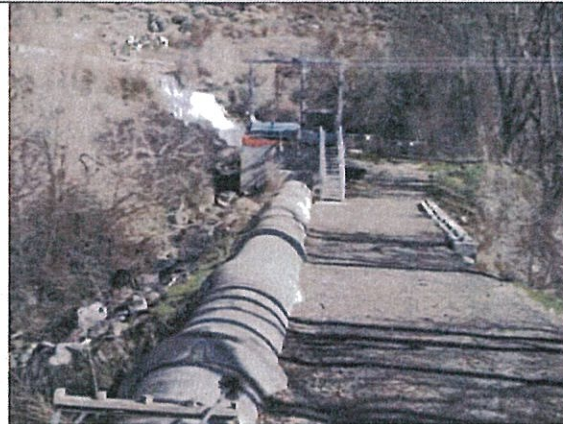
Mr. Chapman explained that the traveling screen resides at the headbox. The water enters the headbox and after passing through the traveling screen, goes to the 48" RCP (reinforced cement pipe) pipeline that sends water to the outside raceways.

Digital 6 – Influent Traveling Screen

Digital 7 – Influent Traveling Screen

Traveling Screen by Headbox to pipeline.

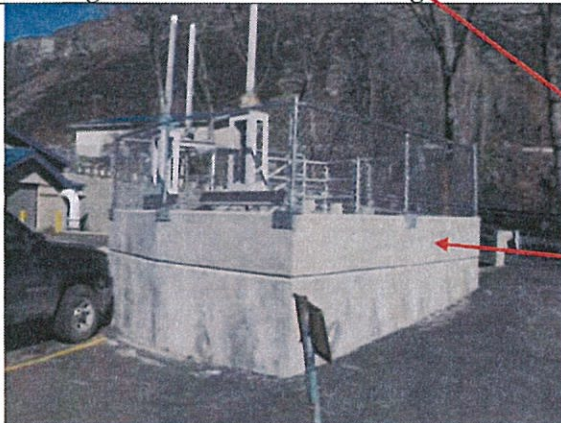
Digital 8 – Splitter Box

Splitter Box that takes Niagara Springs influent water to the Outside Raceways.

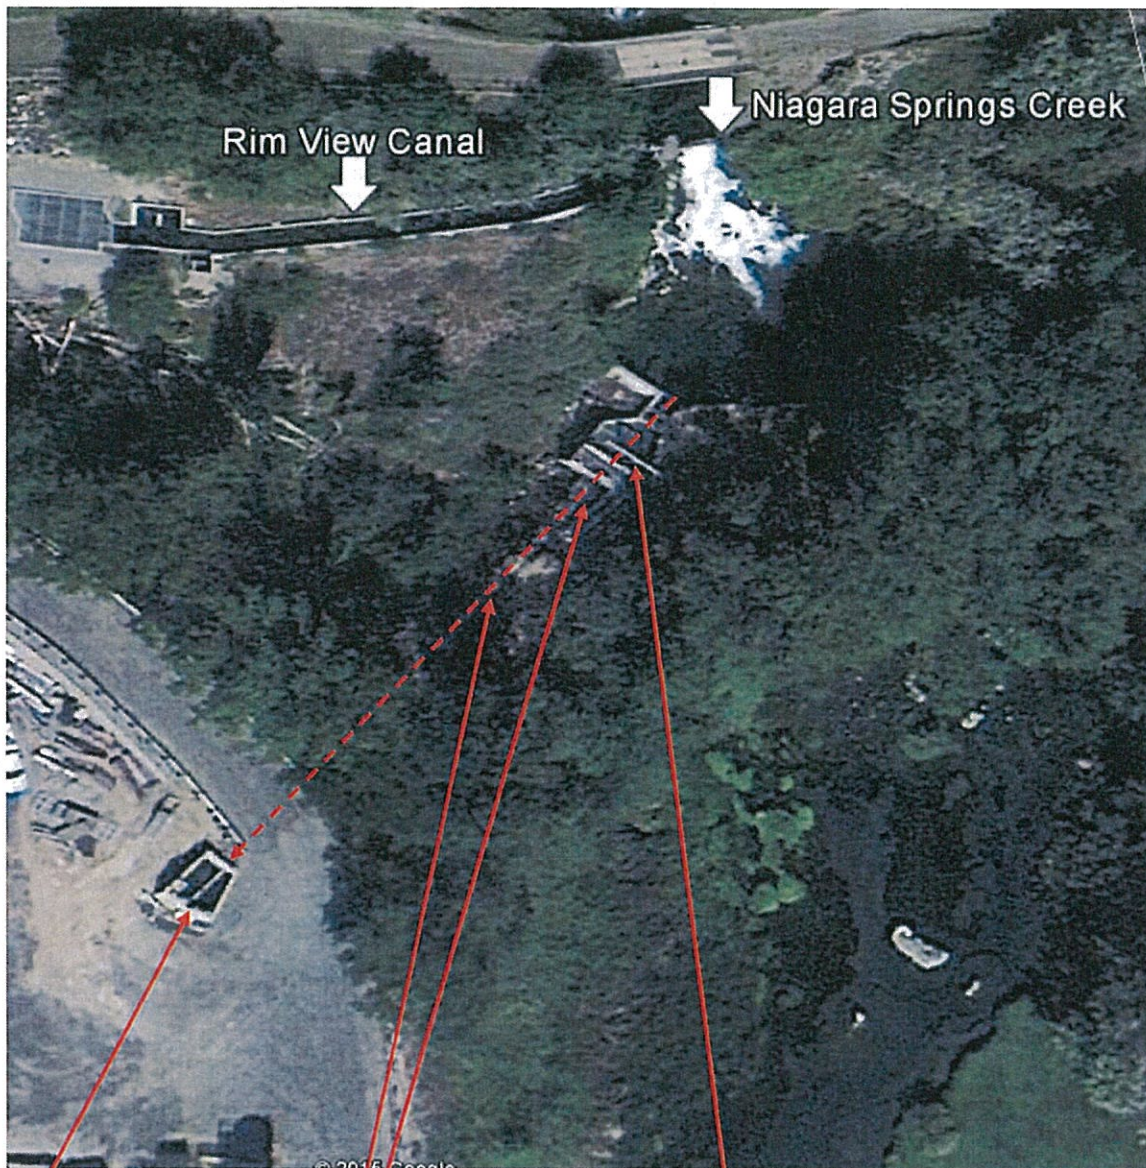
The following Google Earth figure shows the approximate location of the Niagara Springs Creek water (coming from the Niagara Springs Source) to the Headbox with the Traveling Screen through the cement Pipeline to the Splitter Box.

Splitter Box

Cement Pipeline

Headbox with Traveling Screen

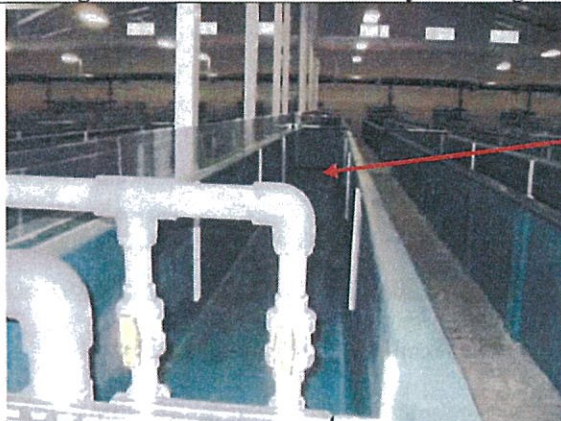
Digital 11. Vats inside Hatchery Building

Vats (or Inside Raceways) inside the Hatchery Building

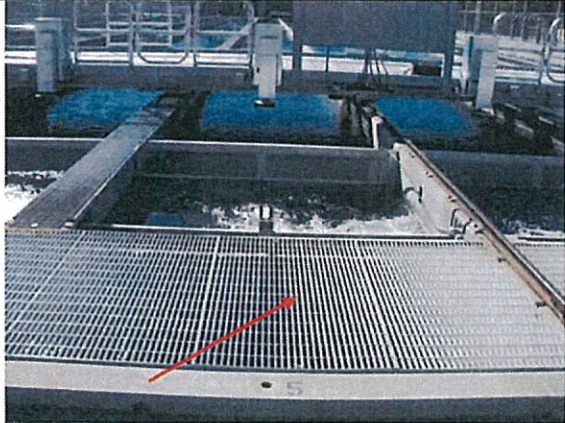
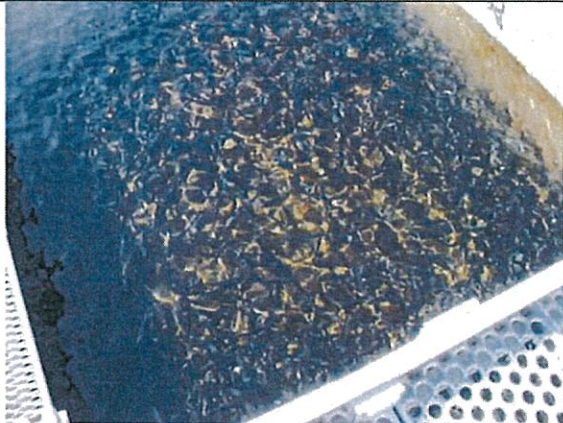
Digital 12. Raceway #5 Headrace	Digital 13. Steelhead in Raceway #5

1. Any excessive feed in the raceways?	<p>Yes No – IDEQ noted no excessive feed in the raceways.</p>
2. Any excessive solids stirred up in raceways?	<p>Yes No – IDEQ noted no excessive solids stirred up in the raceways.</p>

3. Are all the barrier dam boards in place and level?	<p>Yes – IDEQ noted that the dam boards were all in place and level. No</p>
4. Any excessive solids built up in quiescent zones?	<p>Yes No – Mr. Chapman explained that there are no quiescent zones on the facility.</p>

5. Any excessive solids going over the dam boards.	<p>Yes No – IDEQ noted no excessive solids going over the dam boards.</p>
6. Any fish observed in the quiescent zones?	<p>Yes No – Mr. Chapman explained that there are no quiescent zones on the facility.</p>
<p>7. Raceway Cleaning of Outside Raceways – Mr. Chapman explained that the outside raceways have automated cleaning. Three air blower motors supply weighted, perforated, air lines on the bottom side corner of each pond. The resulting water currents keeps organic waste material suspended along the length of the ponds; thus minimizing the need to sweep waste from the ponds.</p>

Digital 12. Headrace of Raceway #5 shown by red arrow pointing to it.

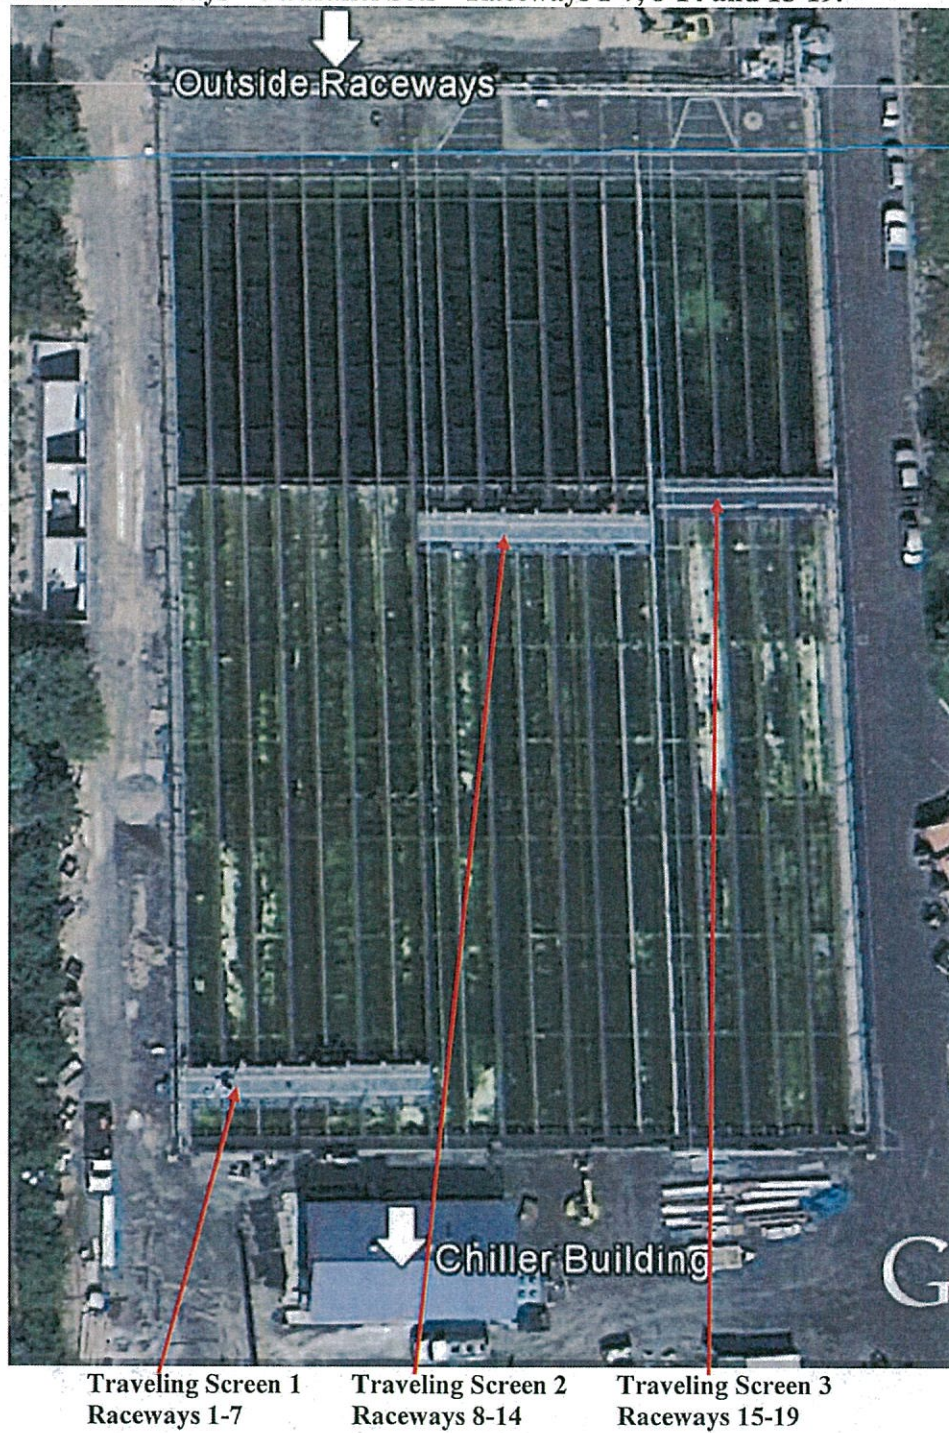
Outside Raceways – 3 Parallel Sets – Raceways 1-7, 8-14 and 15-19.

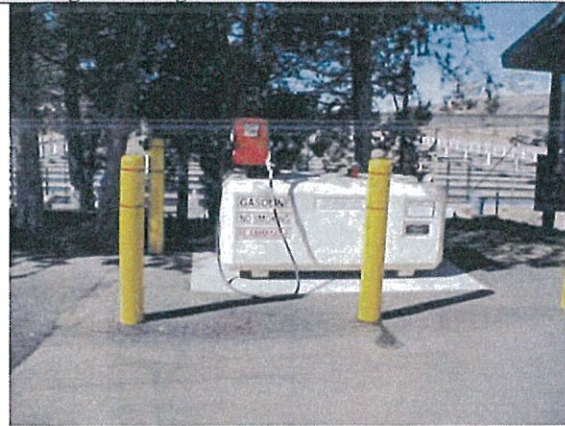
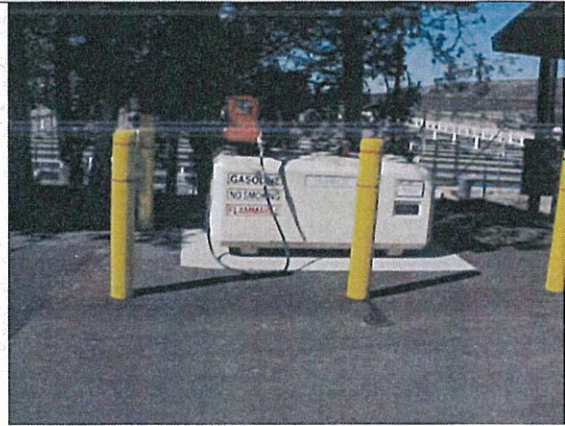
Mr. Chapman explained that the fuel tank area is situated in an outside area, away from the buildings, for refueling of their vehicles. IDEQ noted some minor historical stains where vehicles park for refueling. No smells from the fuel tank were noted. The fuel tank area is located west of Raceway #1 and south of the new Storage Building.

Digital 14. Fuel Tank Area

Digital 15. Fuel Tank Area

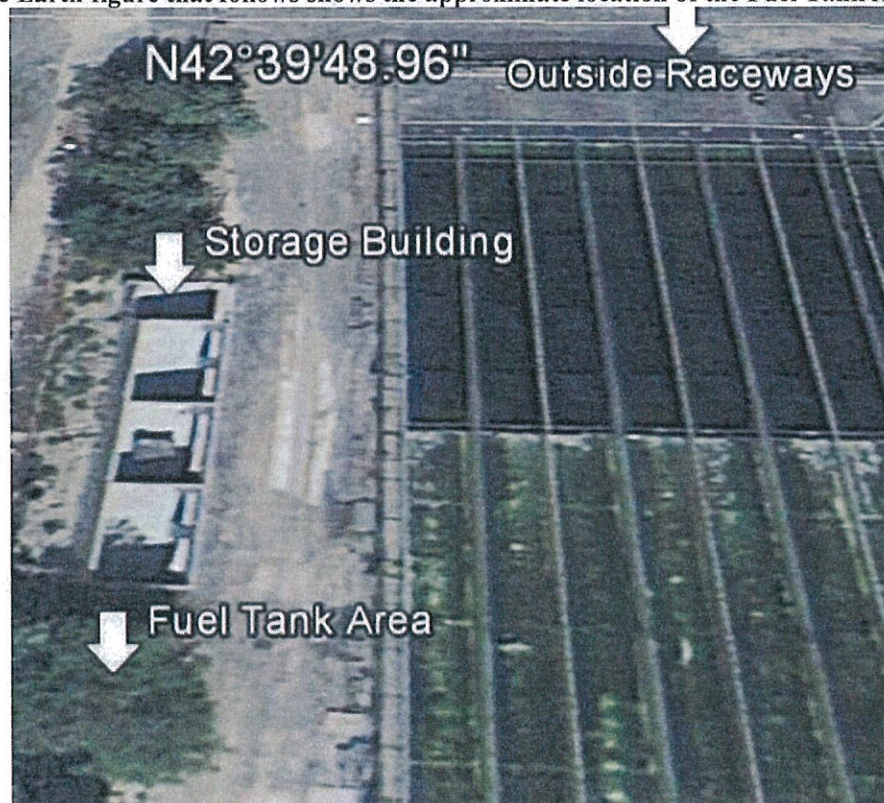
The Google Earth figure that follows shows the approximate location of the Fuel Tank Area.

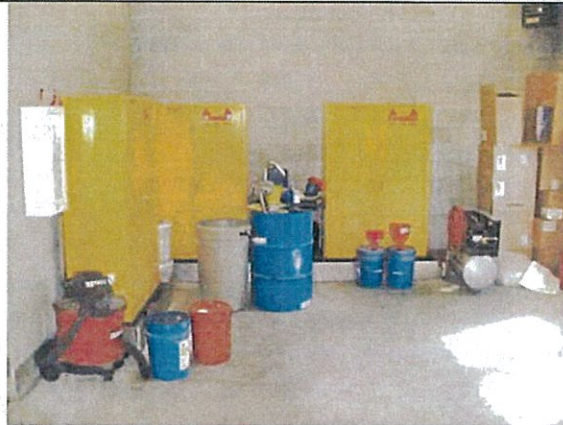
Digital 17. Inside Chiller Building – Chemical Storage

The chiller building is located south of the outside raceways and north of the FFBSs (just north of the West FFBS). The Chlorine Storage Building is located between the Chiller Building and the West FFBS.

Digital 17. Only oil was being contained in the 3 storage containers. No chemical storage was present.

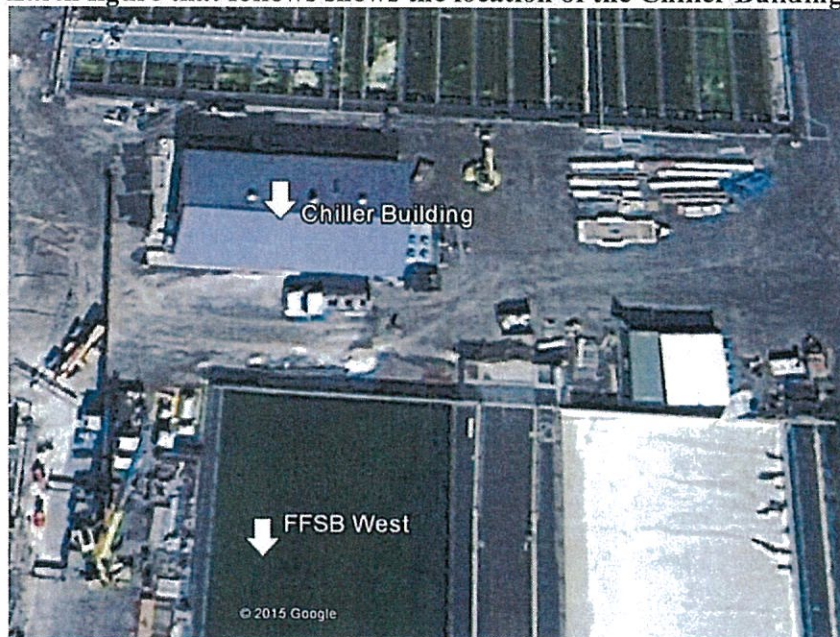
The Google Earth figure that follows shows the location of the Chiller Building.

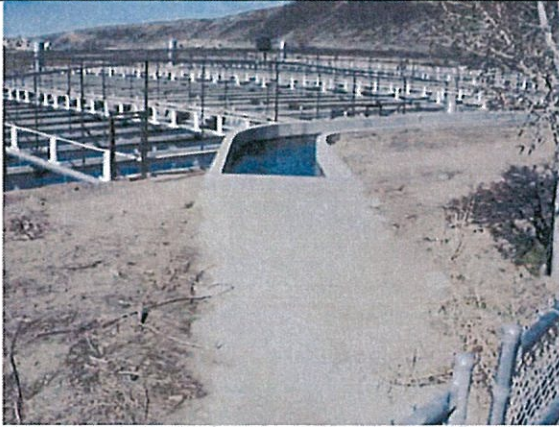
Digital 23. Rim View Diversion Channel (or Canal)

Mr. Chapman demonstrated the diversion and sampler box to the Rim View Trout Farm that is found at the southwest corner of the West FFSB.

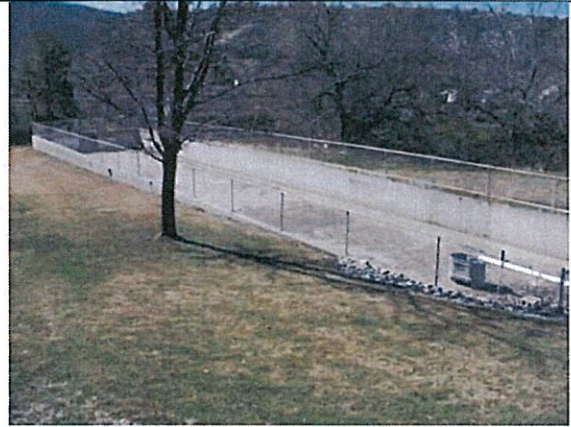
Digital 22. OLSB

Mr. Chapman confirmed that the clean liquid effluent from the FFSBs is “decanted” to the OLSB where it is held temporarily to “polish off” any additional suspended material before discharging to the Snake River only during the time that the FFSBs are being cleaned (which is twice per year). The OLSB was dry at the time of the CEI site tour and was not in use. A pipe runs from the OLSB outfall to the Snake River.

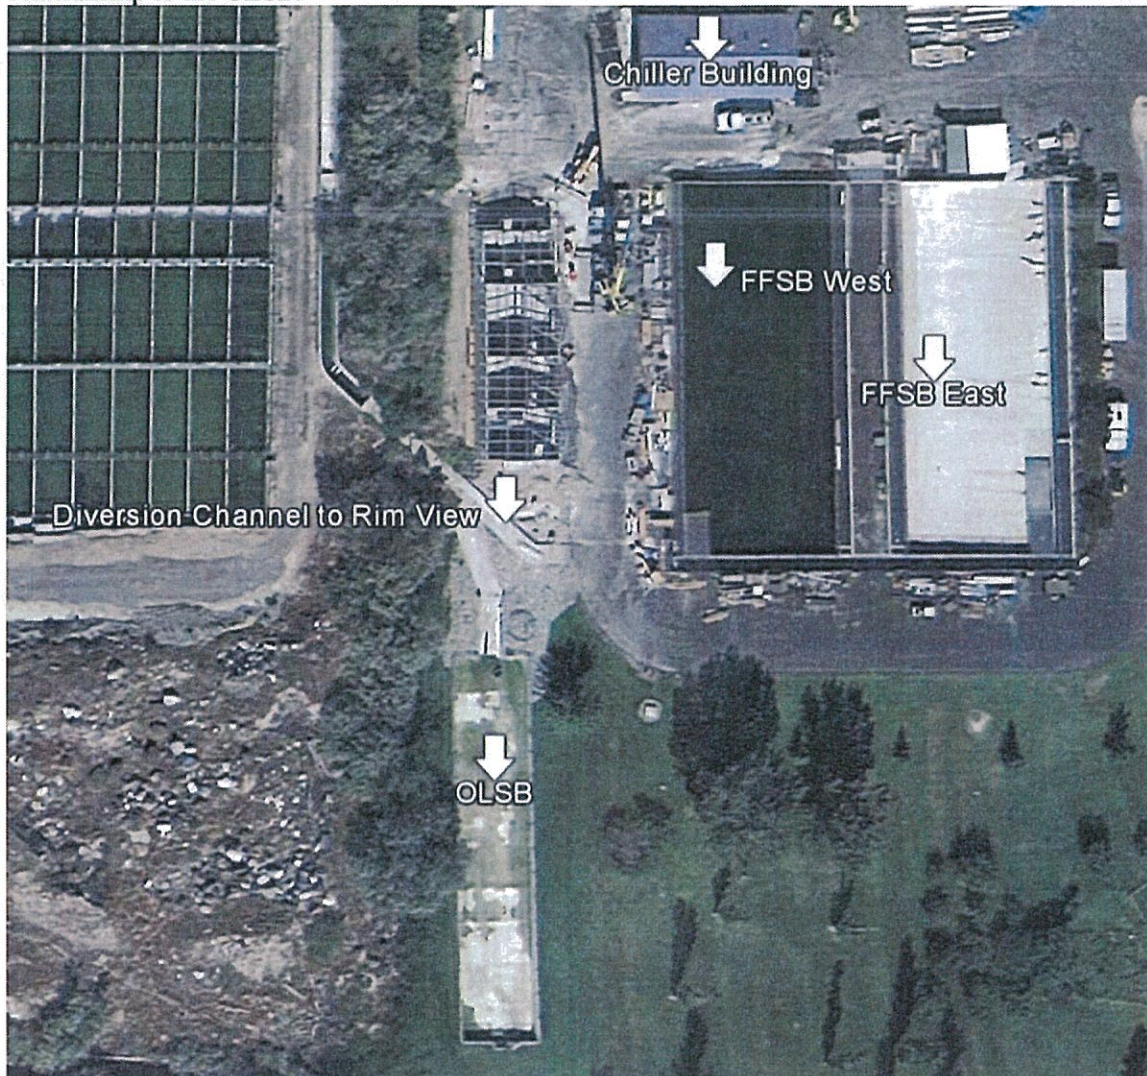
See the following Google Earth figure that shows the OLSB and the Rim View Diversion Channel.

The Google Earth figure that follows shows the approximate location of the Diversion Channel in relationship to the OLSB.

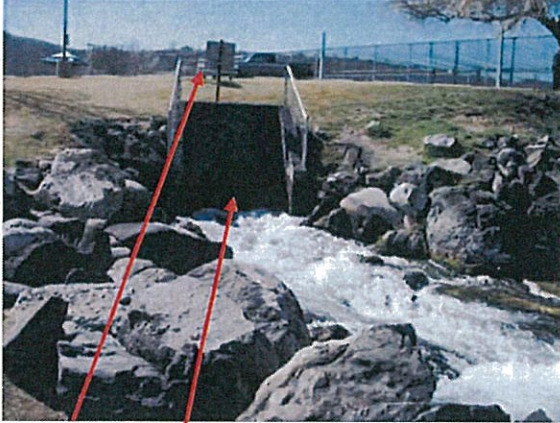
<p>(17) OUTFALL TO NIAGARA SPRINGS CREEK The effluent is monitored by an automatic flow meter that resides underneath the concrete bench. In the two digitals that follow, the concrete bench is shown just above the outfall on the lawn.</p>

<p>Cement Bench where flow meter resides. Digital 24. Outfall to Niagara Springs Creek</p>

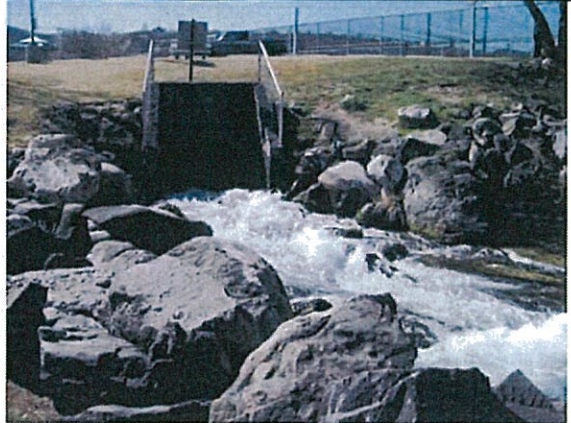
<p>Digital 25. Outfall to Niagara Springs Creek</p>
Are there any unreported outfalls? (check observed against NOI)	<p>Yes</p> <p>No – Mr. Chapman confirmed that there are no additional unreported outfalls on the facility.</p>
If so, describe:	N/A

1. Any floating solids or visible foam in other than trace amounts?	<p>Yes</p> <p>No – IDEQ did not visually see any floating solids or visible foam coming from the effluent outfall into Niagara Springs Creek.</p>

3. Any floating, suspended or submerged matter, including dead fish, in amounts causing nuisance or objectionable condition?	<p>Yes</p> <p>No – IDEQ did not visually see any floating, suspended or submerged matter, including dead fish from the effluent outfall into Niagara Springs Creek.</p>

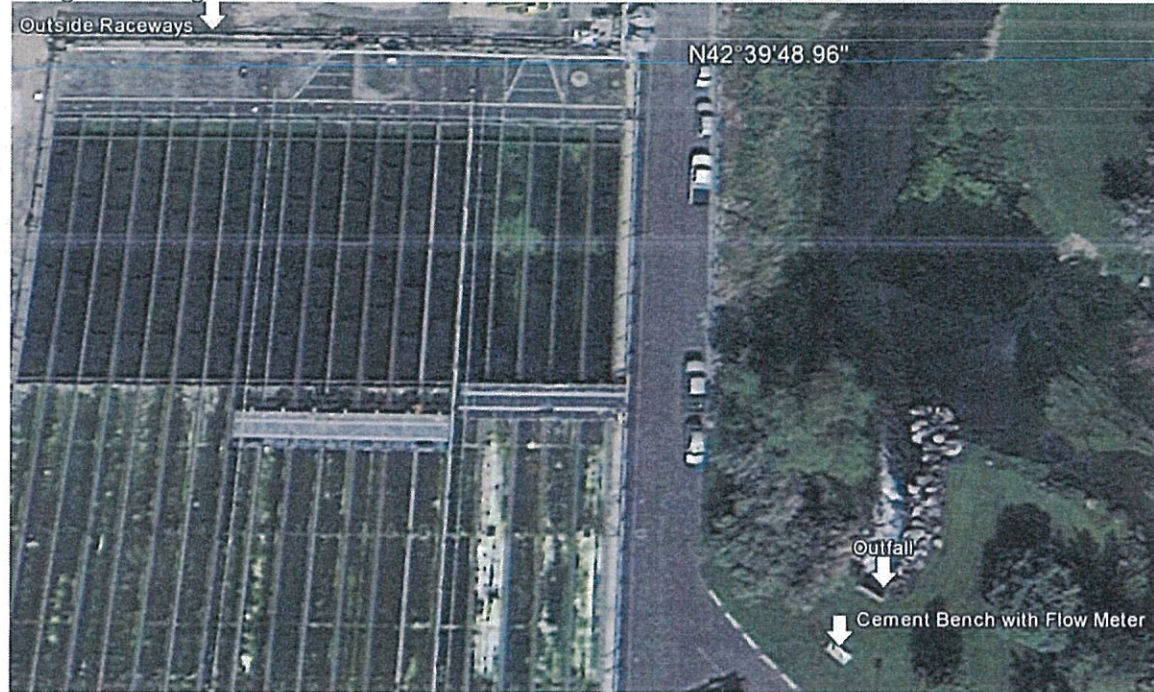
Google Earth figure of Outfall and Flow Meter locations.

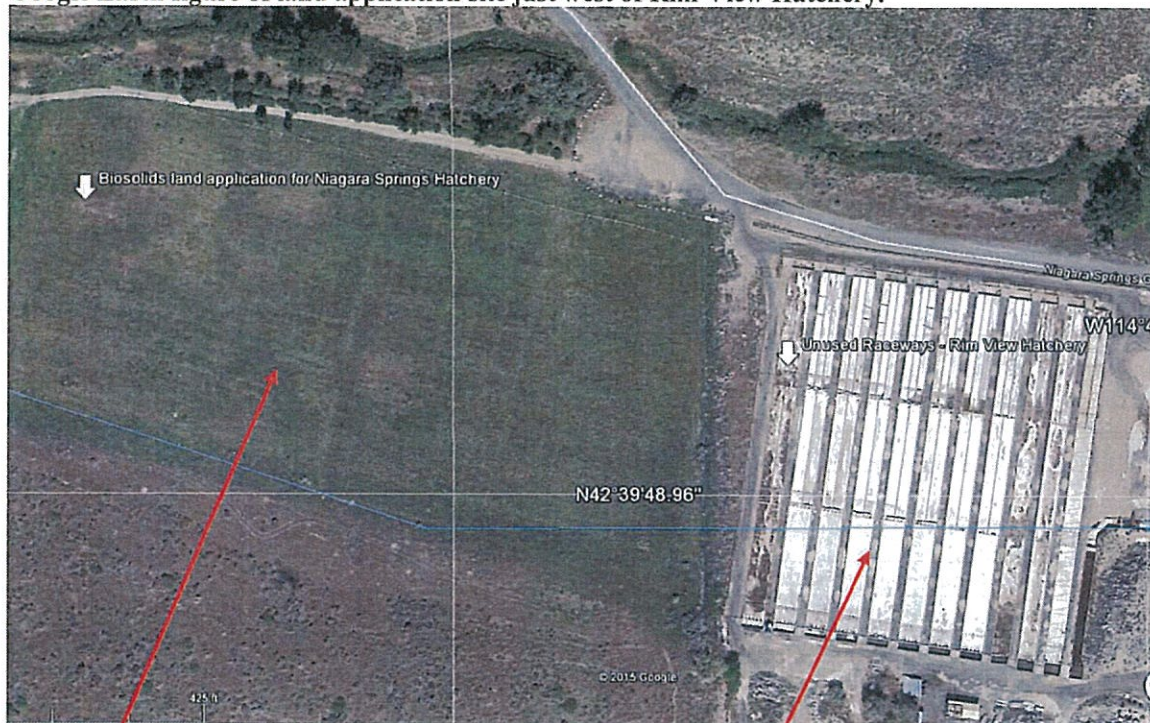
Google Earth figure of land application site just west of Rim View Hatchery.

Land application field for Niagara Springs Hatchery

Rim View Hatchery
